Manhole Inspection Summary

Manhole # S37SS_027MH

Insp Date: **3/2/07 9:57 AM**

Location Address: **413 Whitridge-Alley-27th**

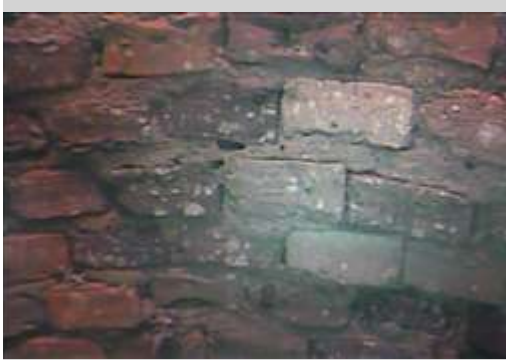
Defect

Count: **0** Missing: **4** ☐ Corroded

Missing steps (4)

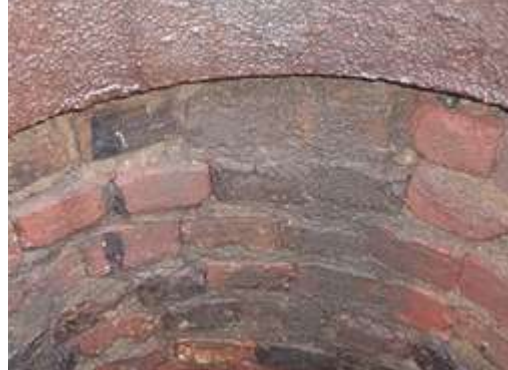
Defect

Condition: ☐ Sound ☐ Cracked ☐ Root Intrusion ☐ Loose Brick ☒ **Deteriorated**

Infiltration: ☐ None ☐ Joint ☐ Cracks ☐ Mortar ☐ Roots ☒ **Wall**

Deterioration on the chimney and infiltration on the corbel wall.

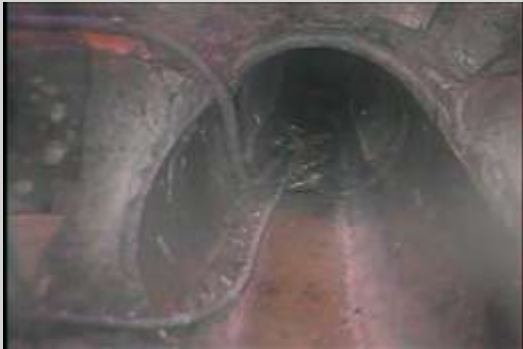
8 in. Circular Gravity Sewer Pipe Out @ 12 O'Clock

Pipe Material: **Clay** ☐ Pipe Lined

Invert Depth: **8.47** (ft.) Flow Characteristics: **Fast**

Deposits: ☒ None ☐ Mud ☐ Sludge ☐ Debris ☐ Grease

Infiltration: **None** Pipe Seal Cond: **Sound**

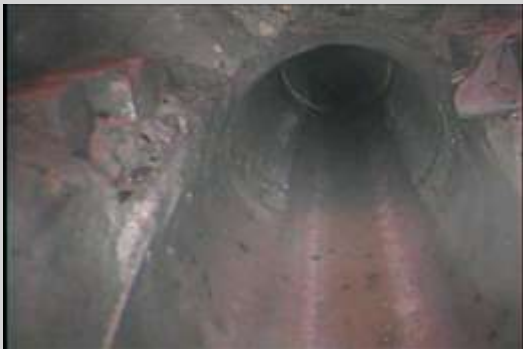
8 in. Circular Gravity Sewer Pipe In @ 6 O'Clock

Pipe Material: **Clay** ☐ Pipe Lined

Invert Depth: **8.39** (ft.) Flow Characteristics: **Fast**

Deposits: ☒ None ☐ Mud ☐ Sludge ☐ Debris ☐ Grease

Infiltration: **None** Pipe Seal Cond: **Sound**

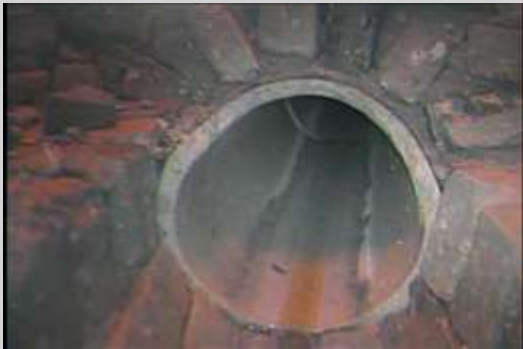
8 in. Circular Gravity Sewer
Pipe In @ 9 O'Clock

Pipe Material: **Clay** ☐ Pipe Lined

Invert Depth: **8.28** (ft.) Flow Characteristics: **Fast**

Deposits: ☒ None ☐ Mud ☐ Sludge ☐ Debris ☐ Grease

Infiltration: **None** Pipe Seal Cond: **Sound**
